TUESDAY TECH TIP

DBNZ Tech Tip of The Week

COOLER MONTHS ARE COMING!

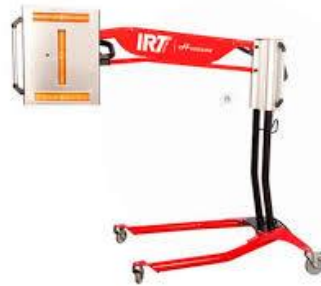
- Curing primer/clearcoat spot repairs with short wave Infra-Red curing technology is one of the fastest ways to cure modern 2k automotive coatings.

An IR unit can be a painter's best friend!

IR Shortwave cure penetrates the entire coating, heating right through to the underlying substrate before coming back up, a full cure can be achieved in as little as 10-12 minutes.

Short Wave IR is a much more efficient way of curing modern automotive coatings.

A 2-way cure is superior to the *top-down* process associated with other heated curing methods in that it produces a more thorough cure and more heat can be applied without fear of skinning and solvent popping.
